BRIDGE INSPECTION REPORT

Agency: Whatcom County

Bridge No. 503A

Bridge Name FERRY SLIP APPR

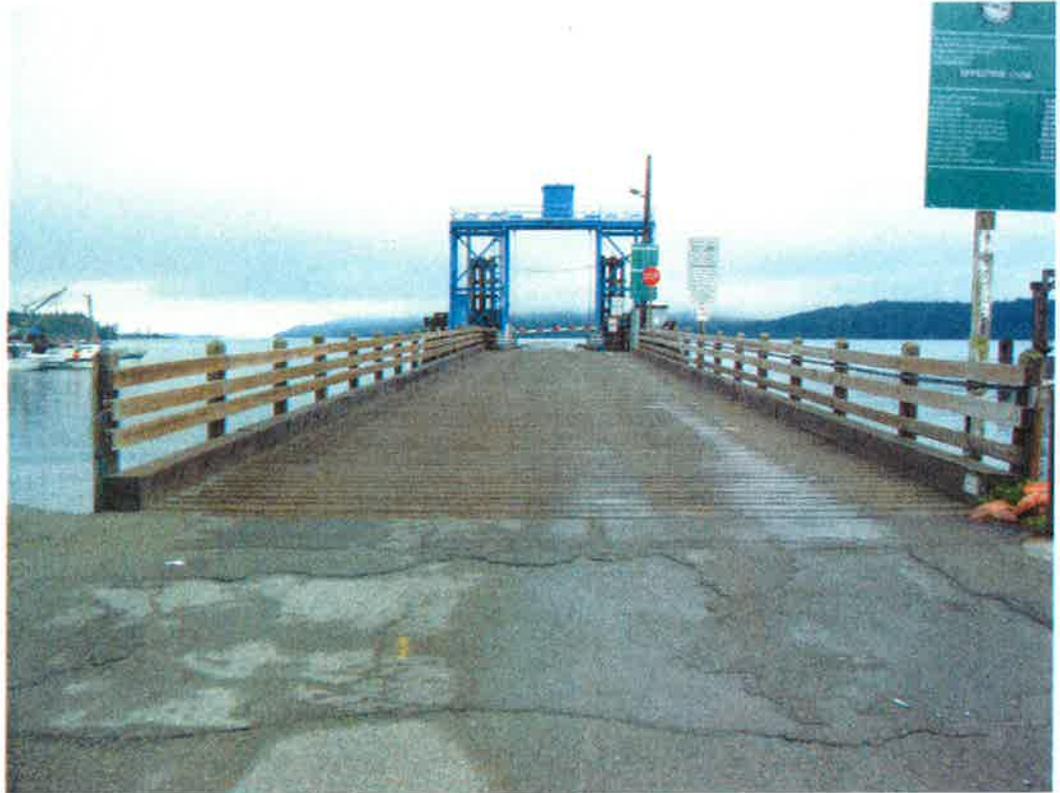
DE-01-12

Deck View

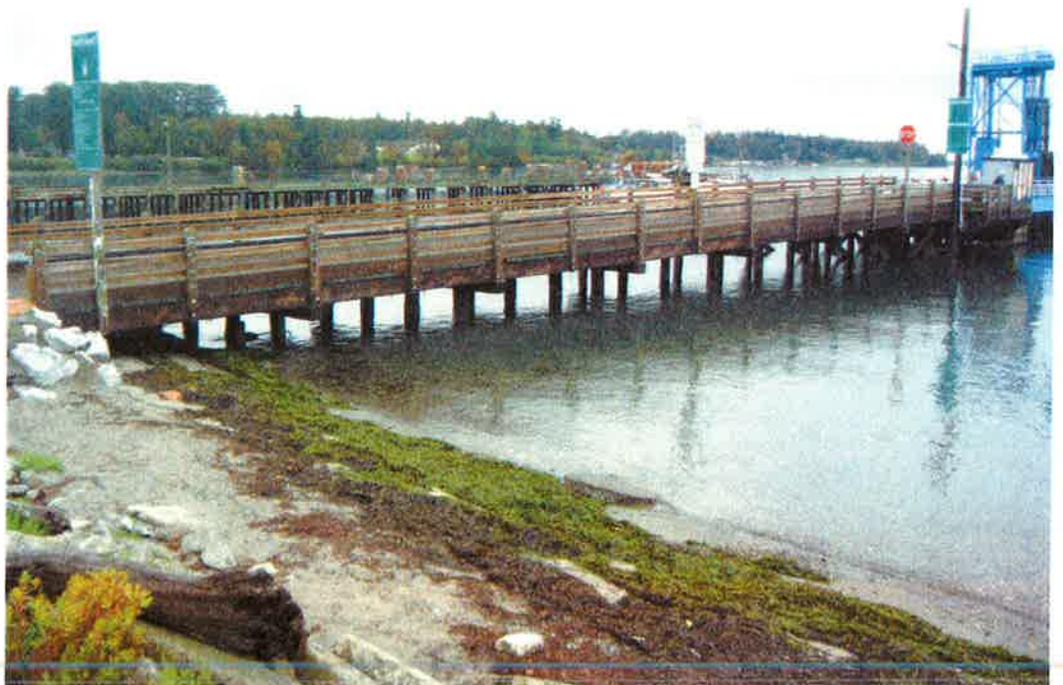
DE-02-12

Elevation View

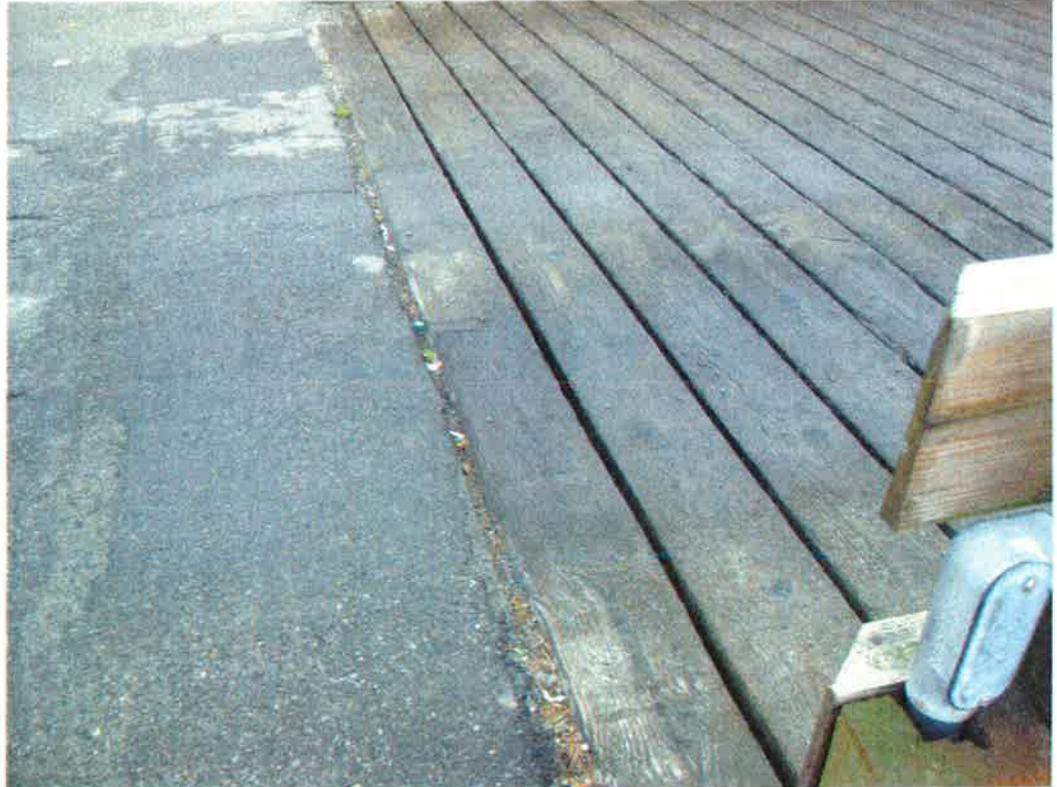
GP-01-12

Bridge approach

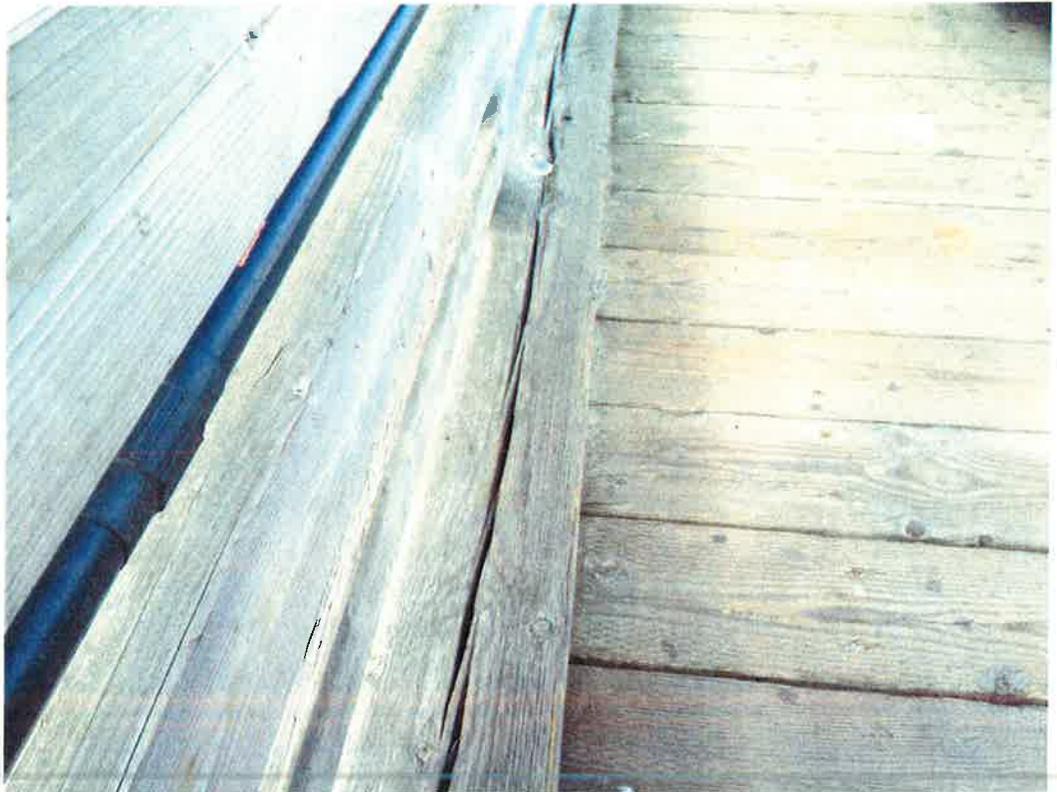
GP-01-14

Crackes in the bull rail on the bridge deck.

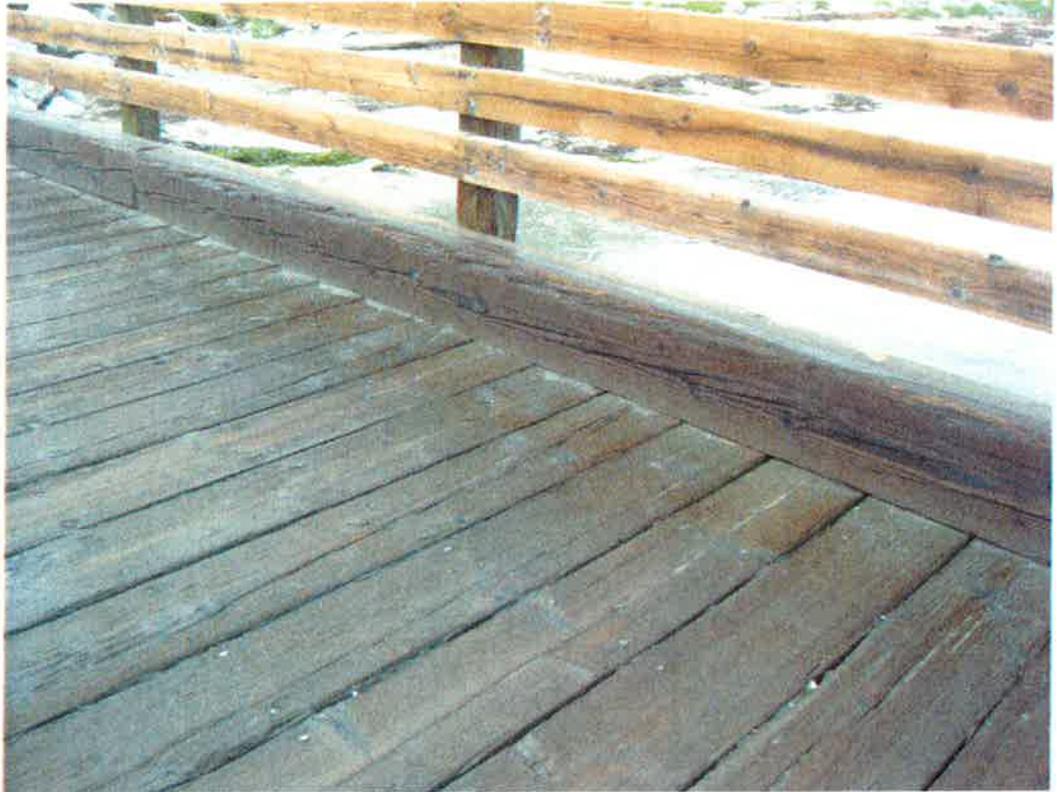
GP-02-12

General Photo
Photo Type: M - Monitor
Orientation: DN
Dates: 9/27/2012
Repairs:
Bull rail is cracked (typ.)

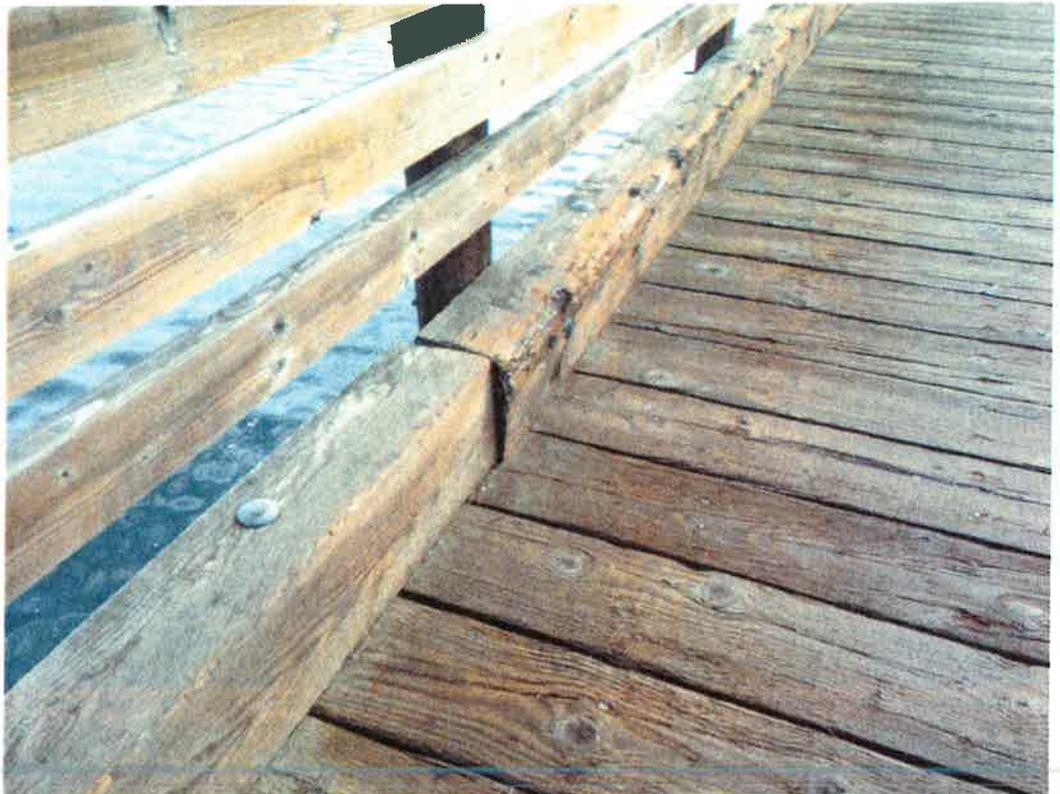
GP-02-14

General Photo
Photo Type: M - Monitor
Orientation: DN
Dates: 9/22/2014
Repairs:
Bull Rail that have twisted

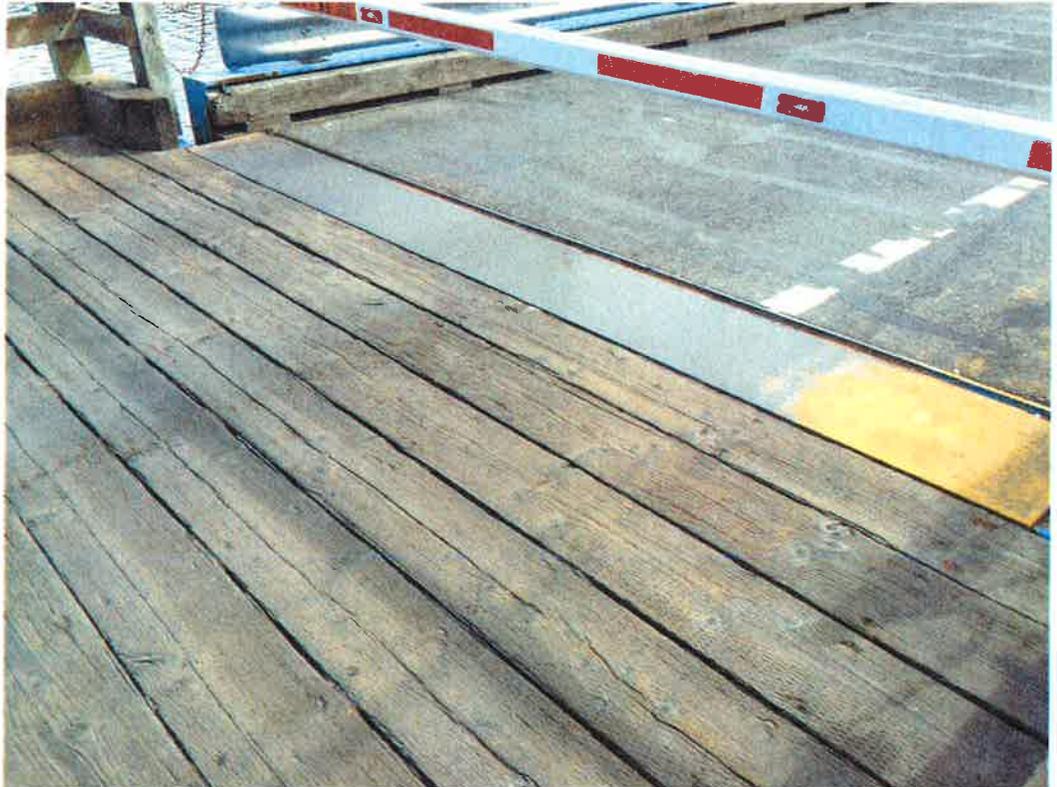
GP-03-14

Typical bridge decking

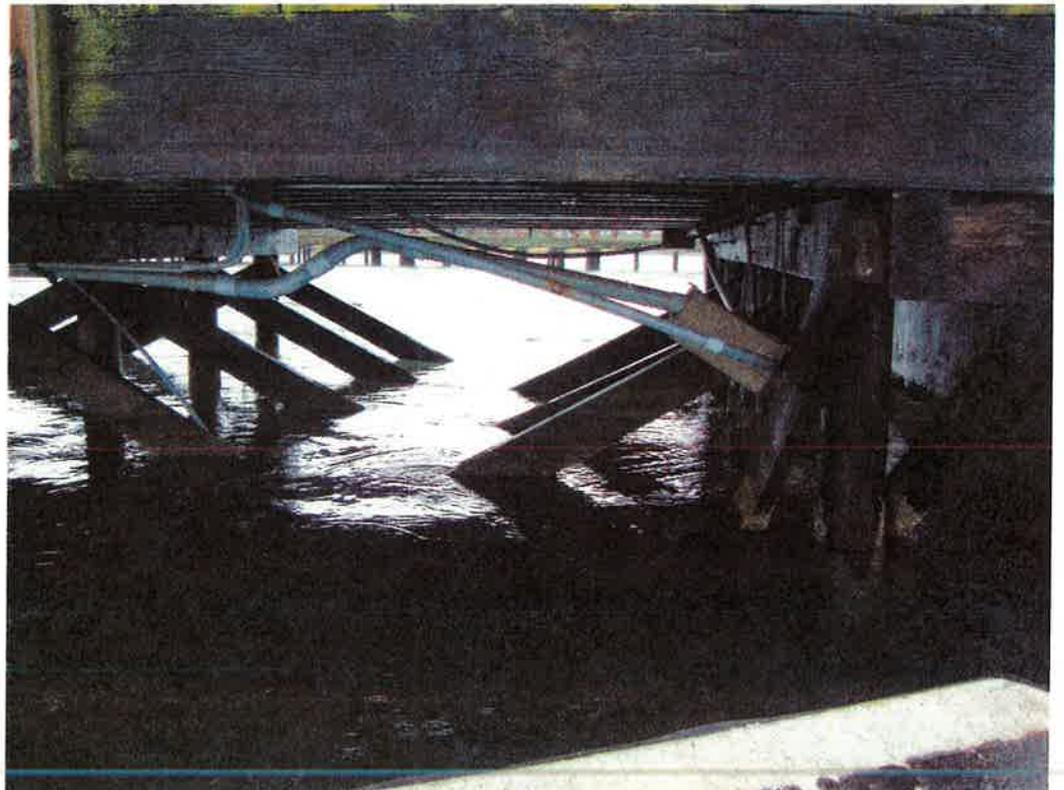
R-01-12

Electrical damaged and end of dock

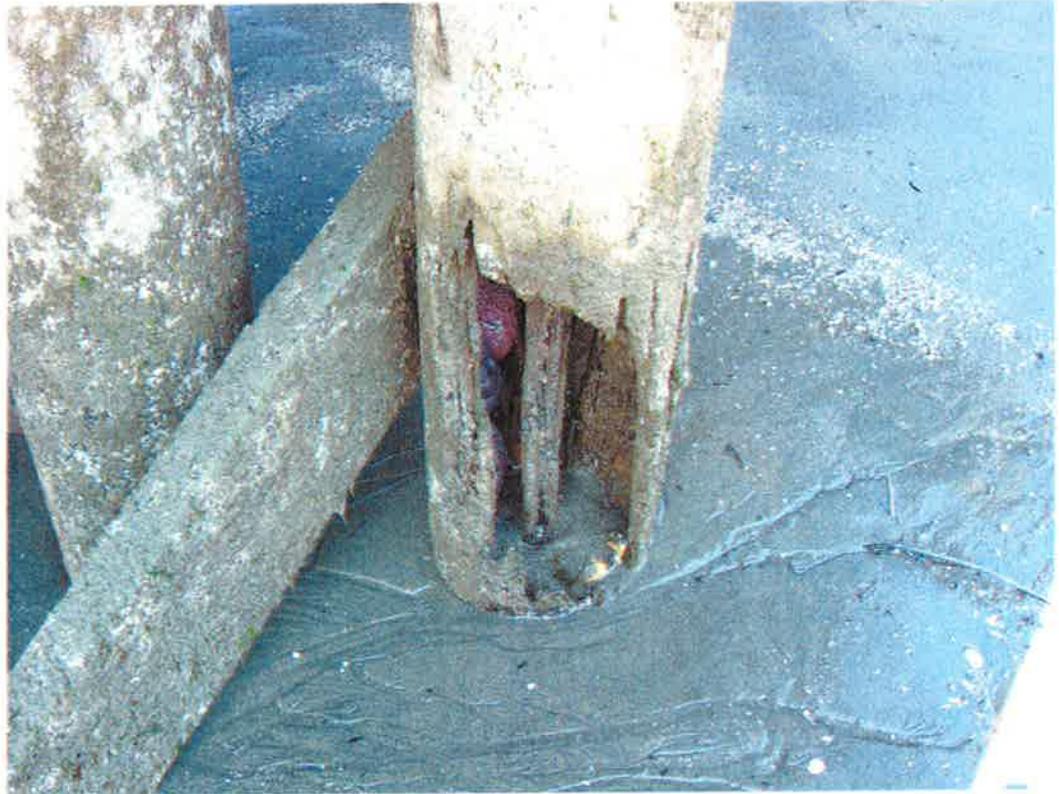
SubS-01-07

Sub-Structure
Photo Type: M - Monitor
Orientation: DN
Dates: 4/20/2007
Repairs:
Rotten pile

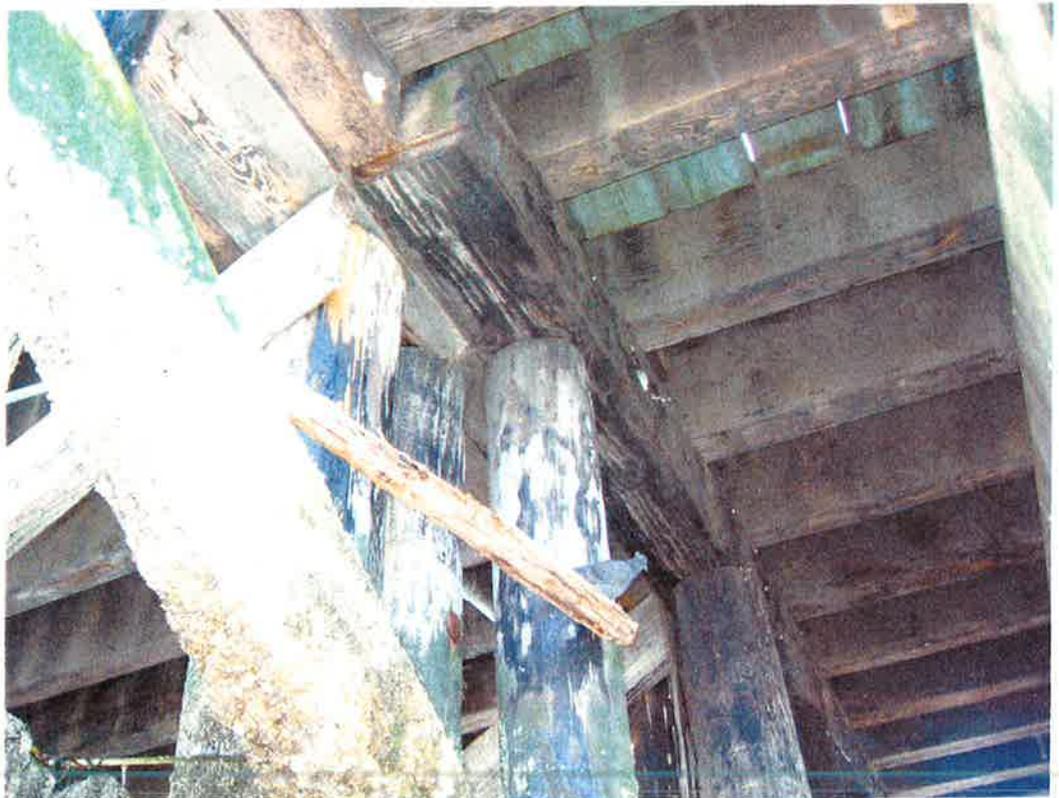
SubS-02-07

Sub-Structure
Photo Type: M - Monitor
Orientation: UP
Dates: 4/20/2007
Repairs:
Looking at timber caps

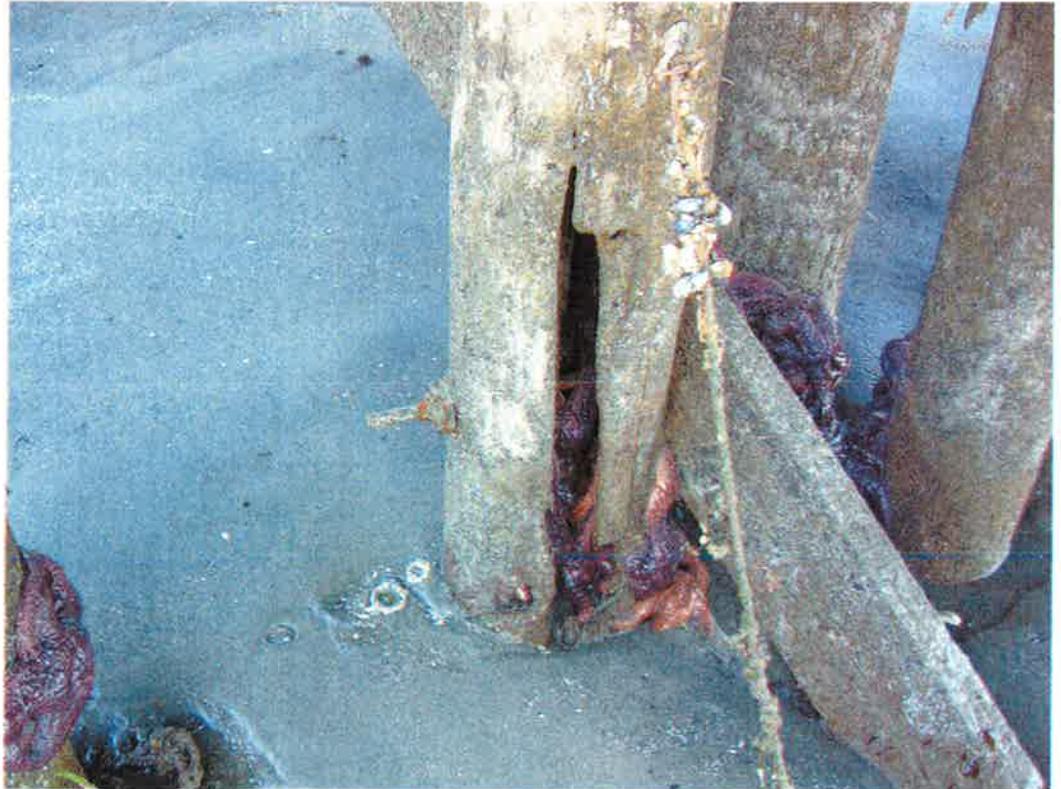
SubS-03-07

Rotten pile

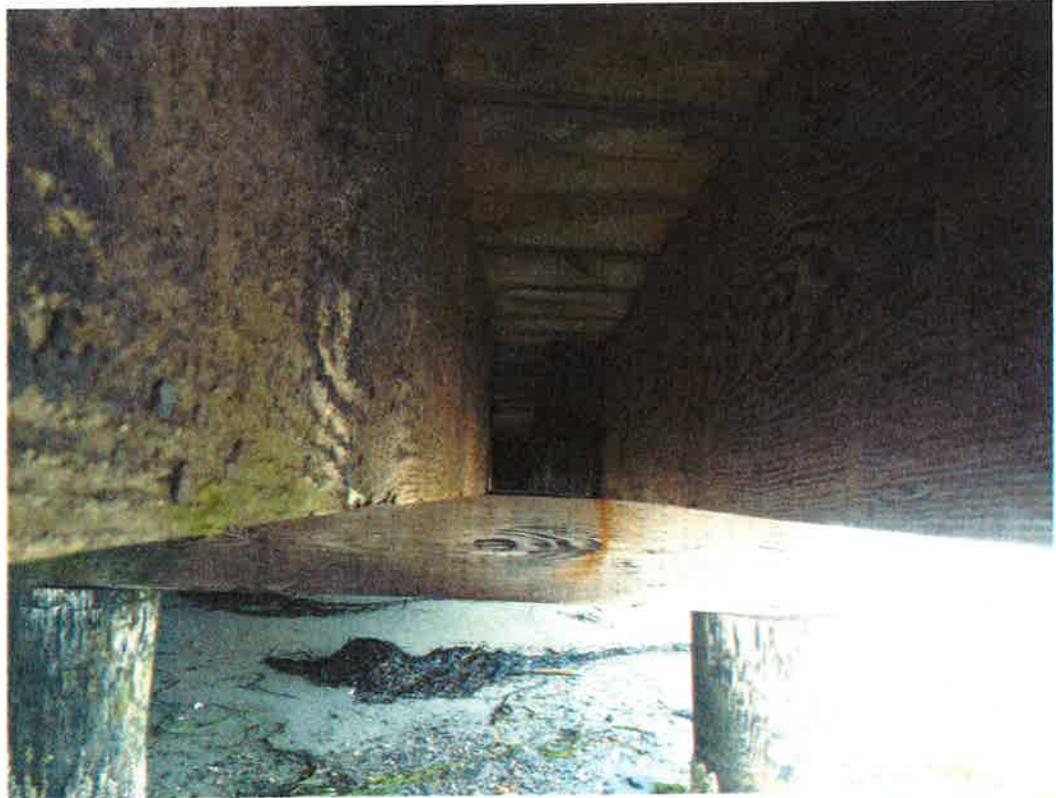
SupS-01-14

0	Dock is oriented North to South and inspection starts at the North (shoreline).
54	Deck planks have moderate wear and a number of the boards have nails that are sticking up from 1/8" to 1/4". Some have been snagged and bent over. The last two timber slabs at the transfer span are loose.
117	Girder 2L at the south end has a split over timber cap #3. Through out the structure a number of the timber girder are starting to twist out of plumb in the vertical direction (see picture SupS-01-14)
215	In good shape.
216	No signs of any issues.

Super Structure
Photo Type: M - Monitor
Orientation: N
Dates: 9/22/2014
Repairs:
Girders with a twist

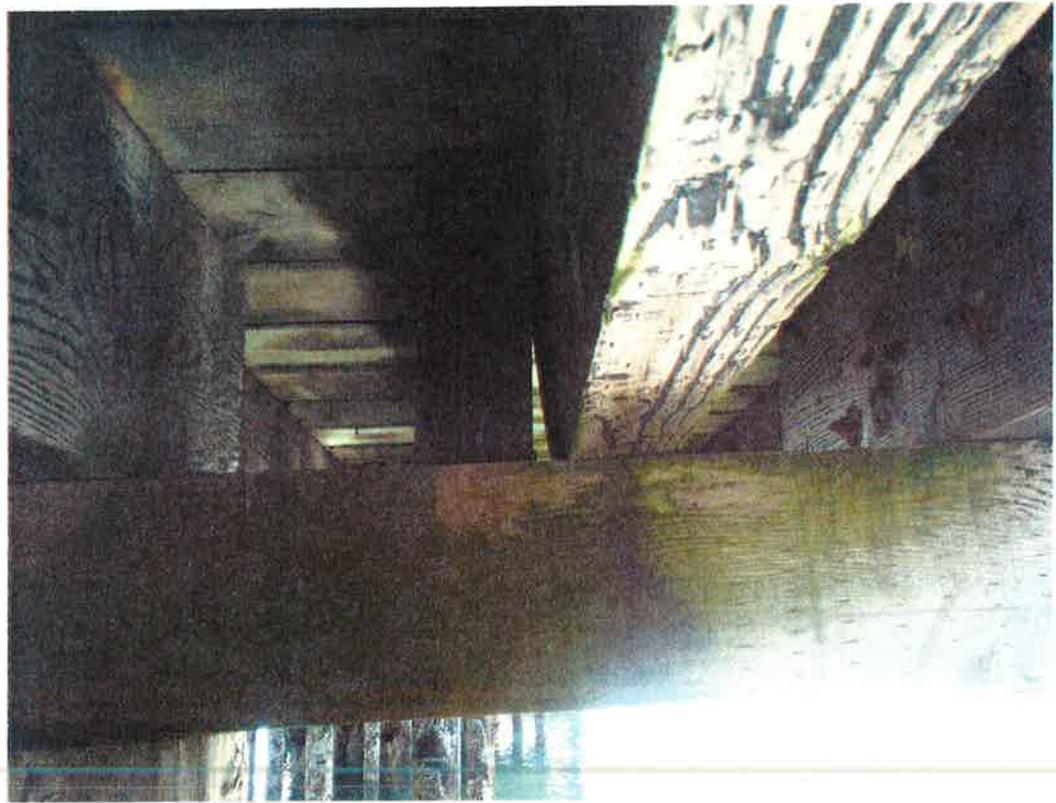
SupS-02-14

Super Structure
Photo Type: M - Monitor
Orientation: N
Dates: 9/22/2014
Repairs:
Another example of the twisted
Girder

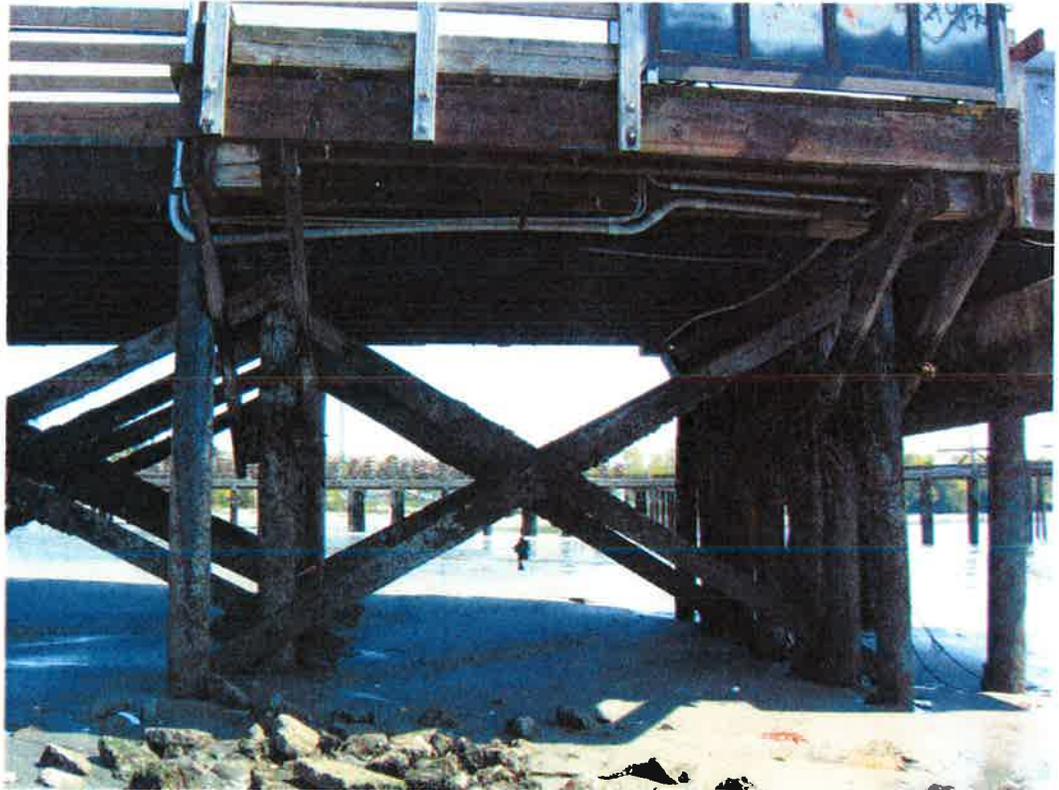
U-01-10

Utilities
Photo Type: U - Utility
Orientation: UP
Dates: 9/13/2010
Repairs:
Electrical Utilities on dock

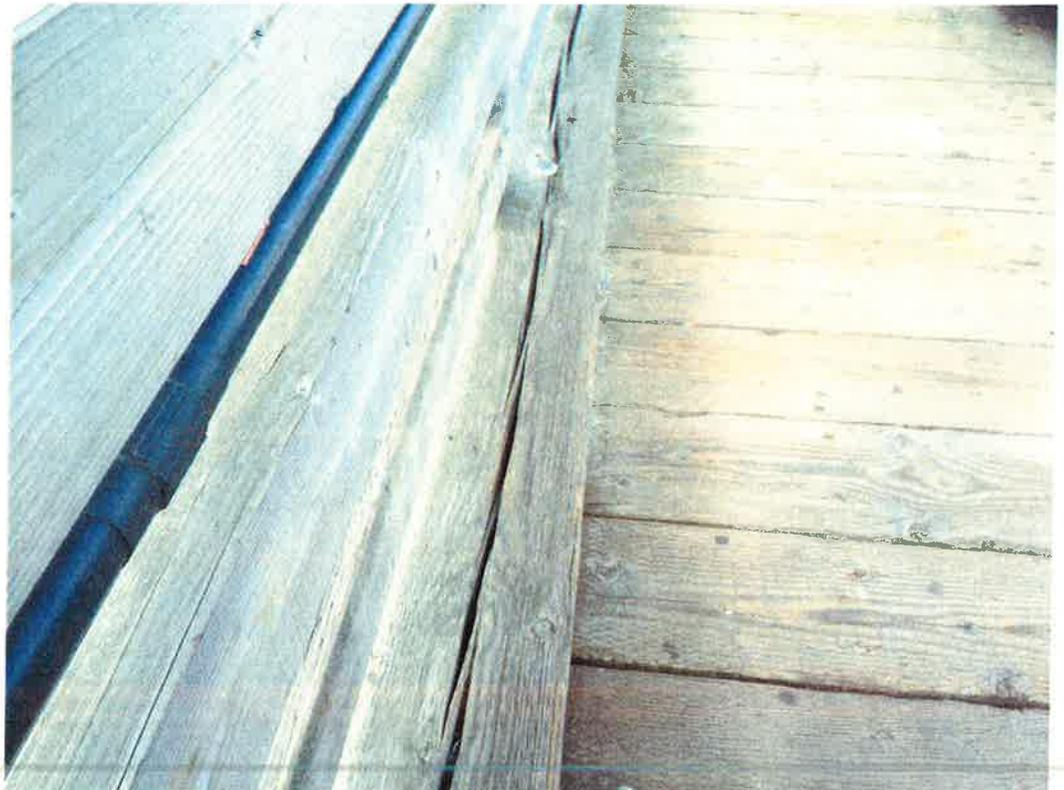
U-01-14

Utilities
Photo Type: U - Utility
Orientation: DN
Dates: 9/22/2014
Repairs:
New electrical line to feed the dock
